Put Your Money Where Your Mouth is

**So That's Exactly
What Was Done**

**Todd Tracy
Dallas, Texas**

**IIHS
Moderate
Overlap Test
Protocol
Followed to
the Letter**

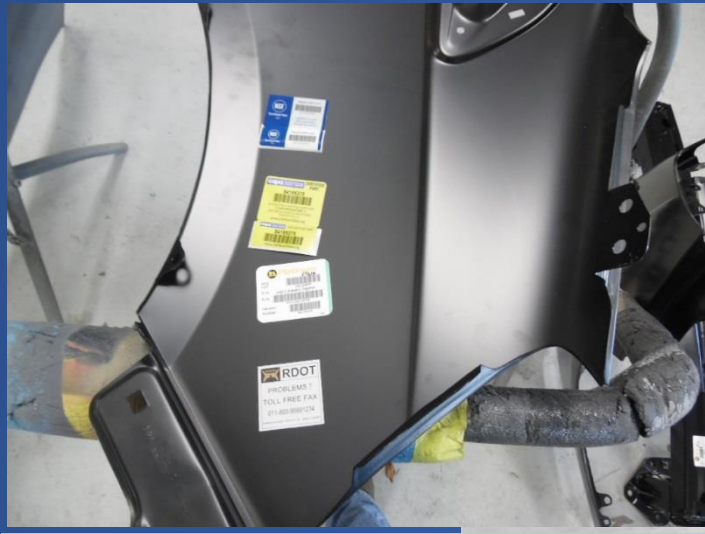
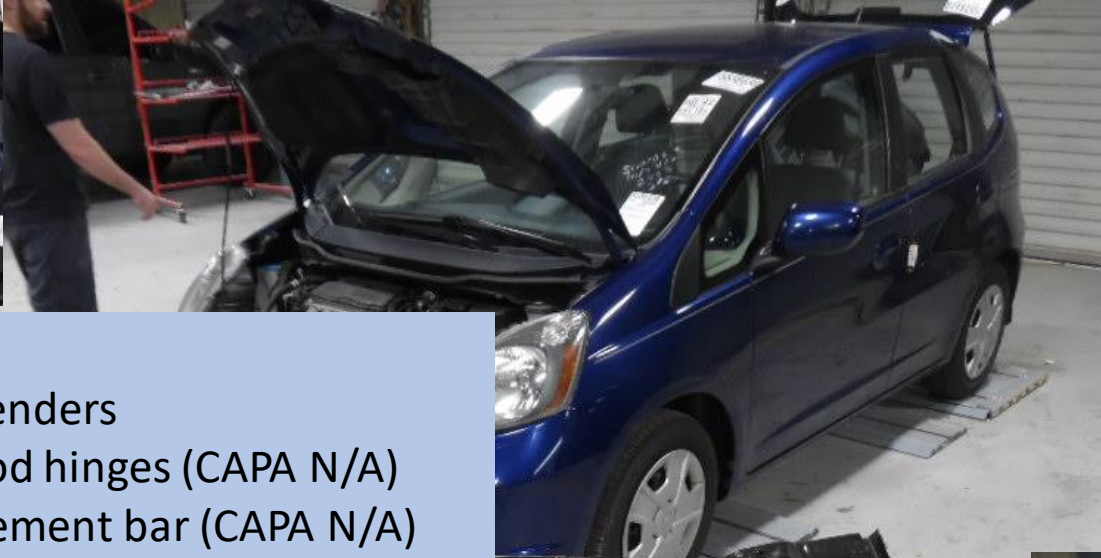
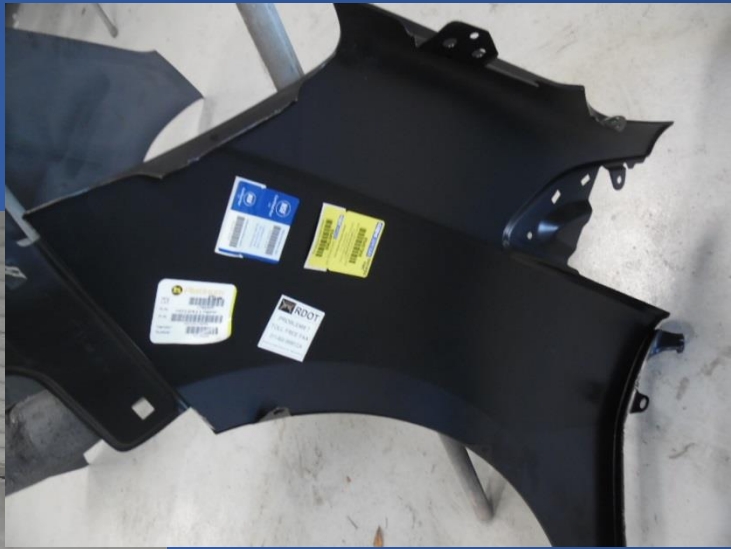
Aftermarket Parts

- 1) CAPA certified Hood
- 2) CAPA certified left and right fenders
- 3) Aftermarket left and right hood hinges (CAPA N/A)
- 4) Aftermarket bumper reinforcement bar (CAPA N/A)
- 5) Aftermarket radiator support (CAPA N/A)
- 6) Aftermarket left front wheel (CAPA N/A)
- 7) Aftermarket front windshield

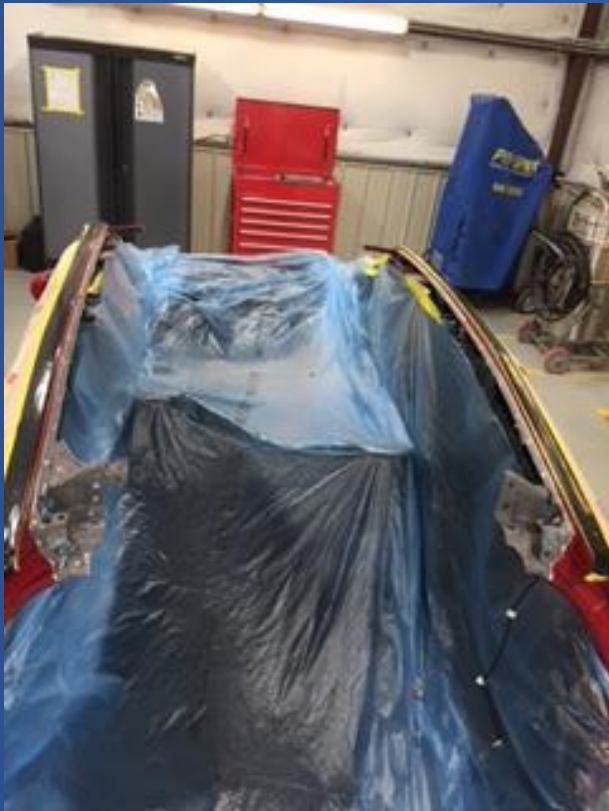
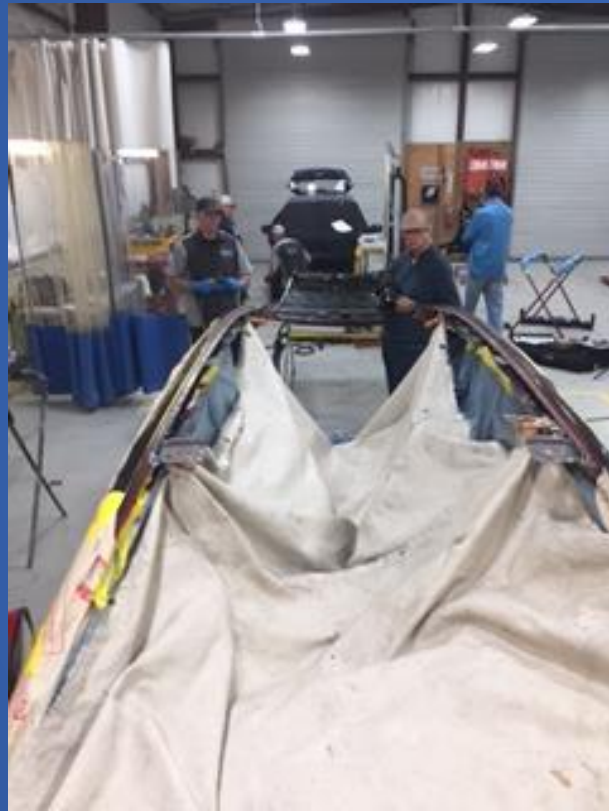
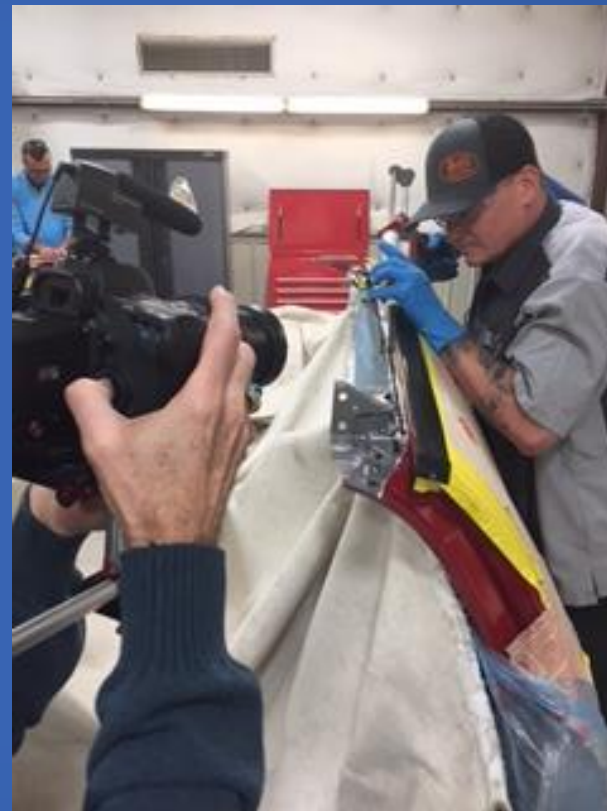
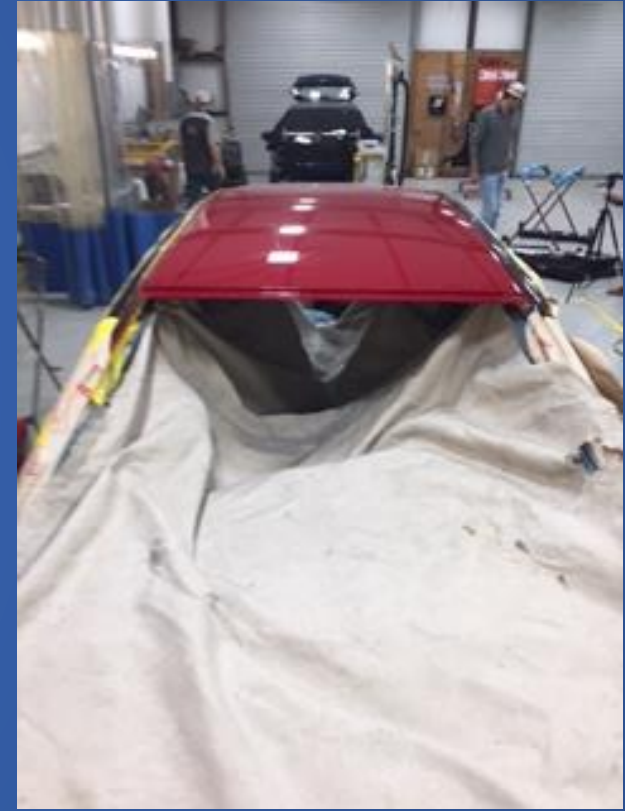
Test #2 (Blue Test)

Roof Removed and Reapplied with Adhesive

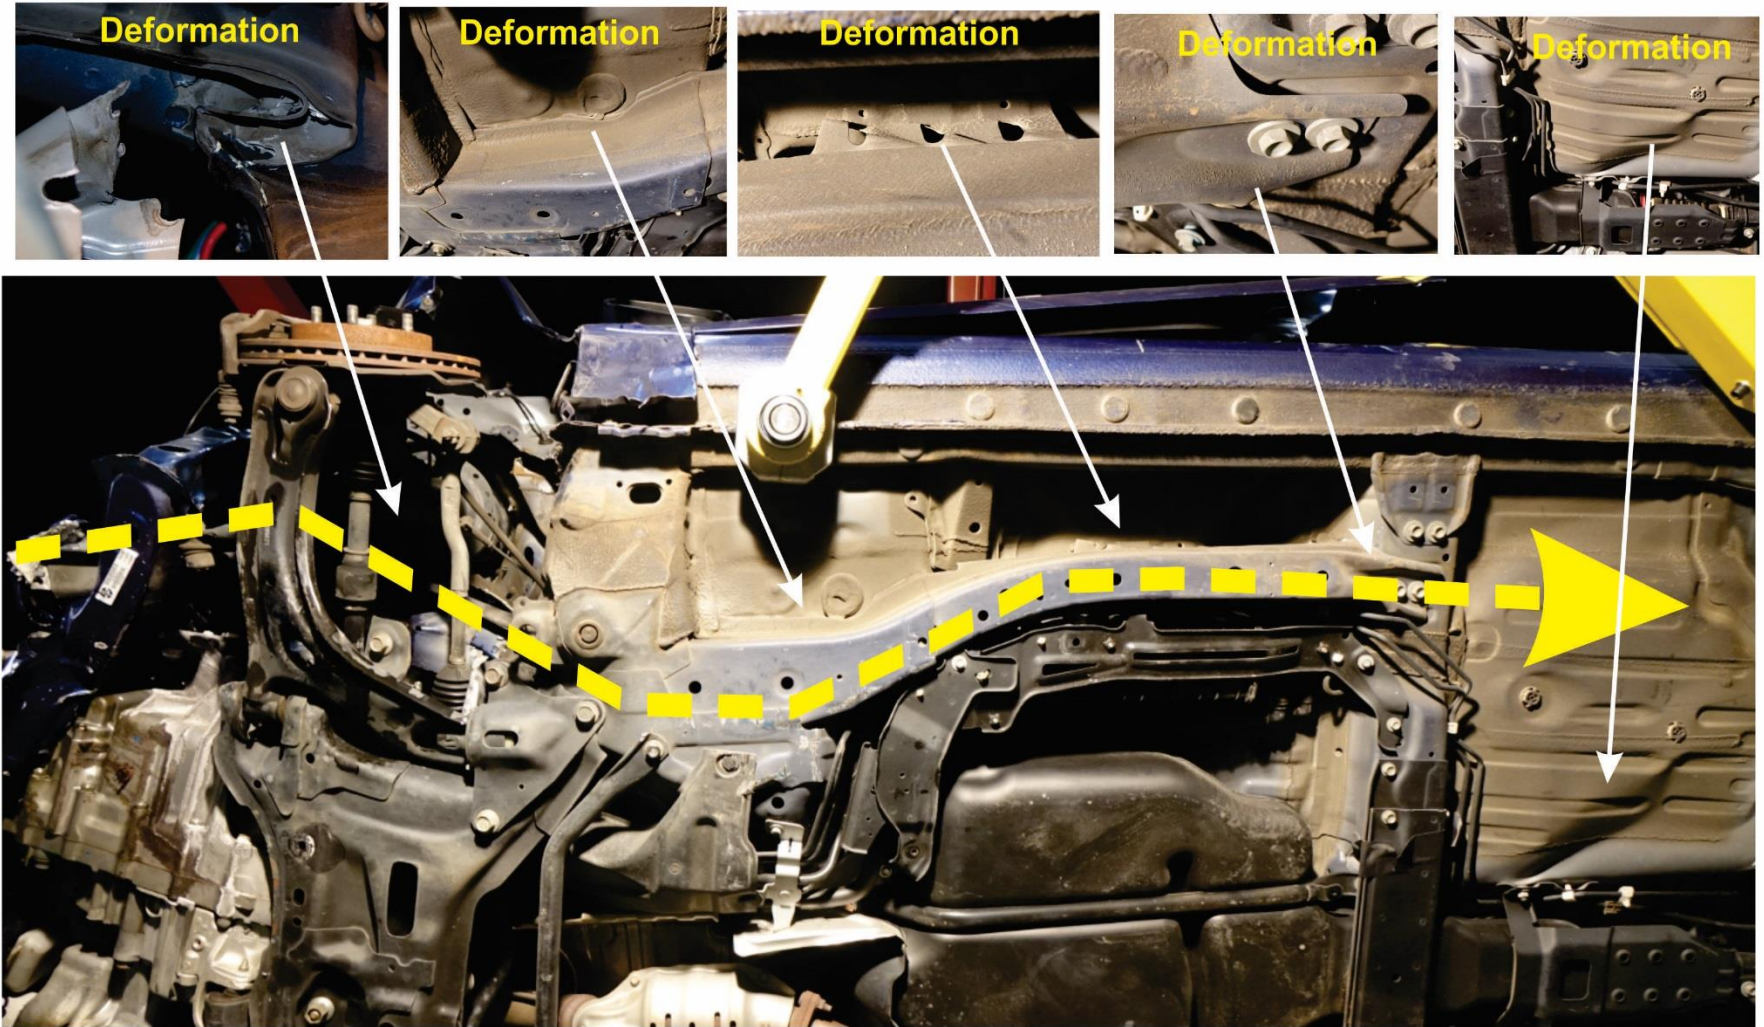
Aftermarket Parts

Structure
Underneath
the
occupants
caused
injurious
vertical
loads

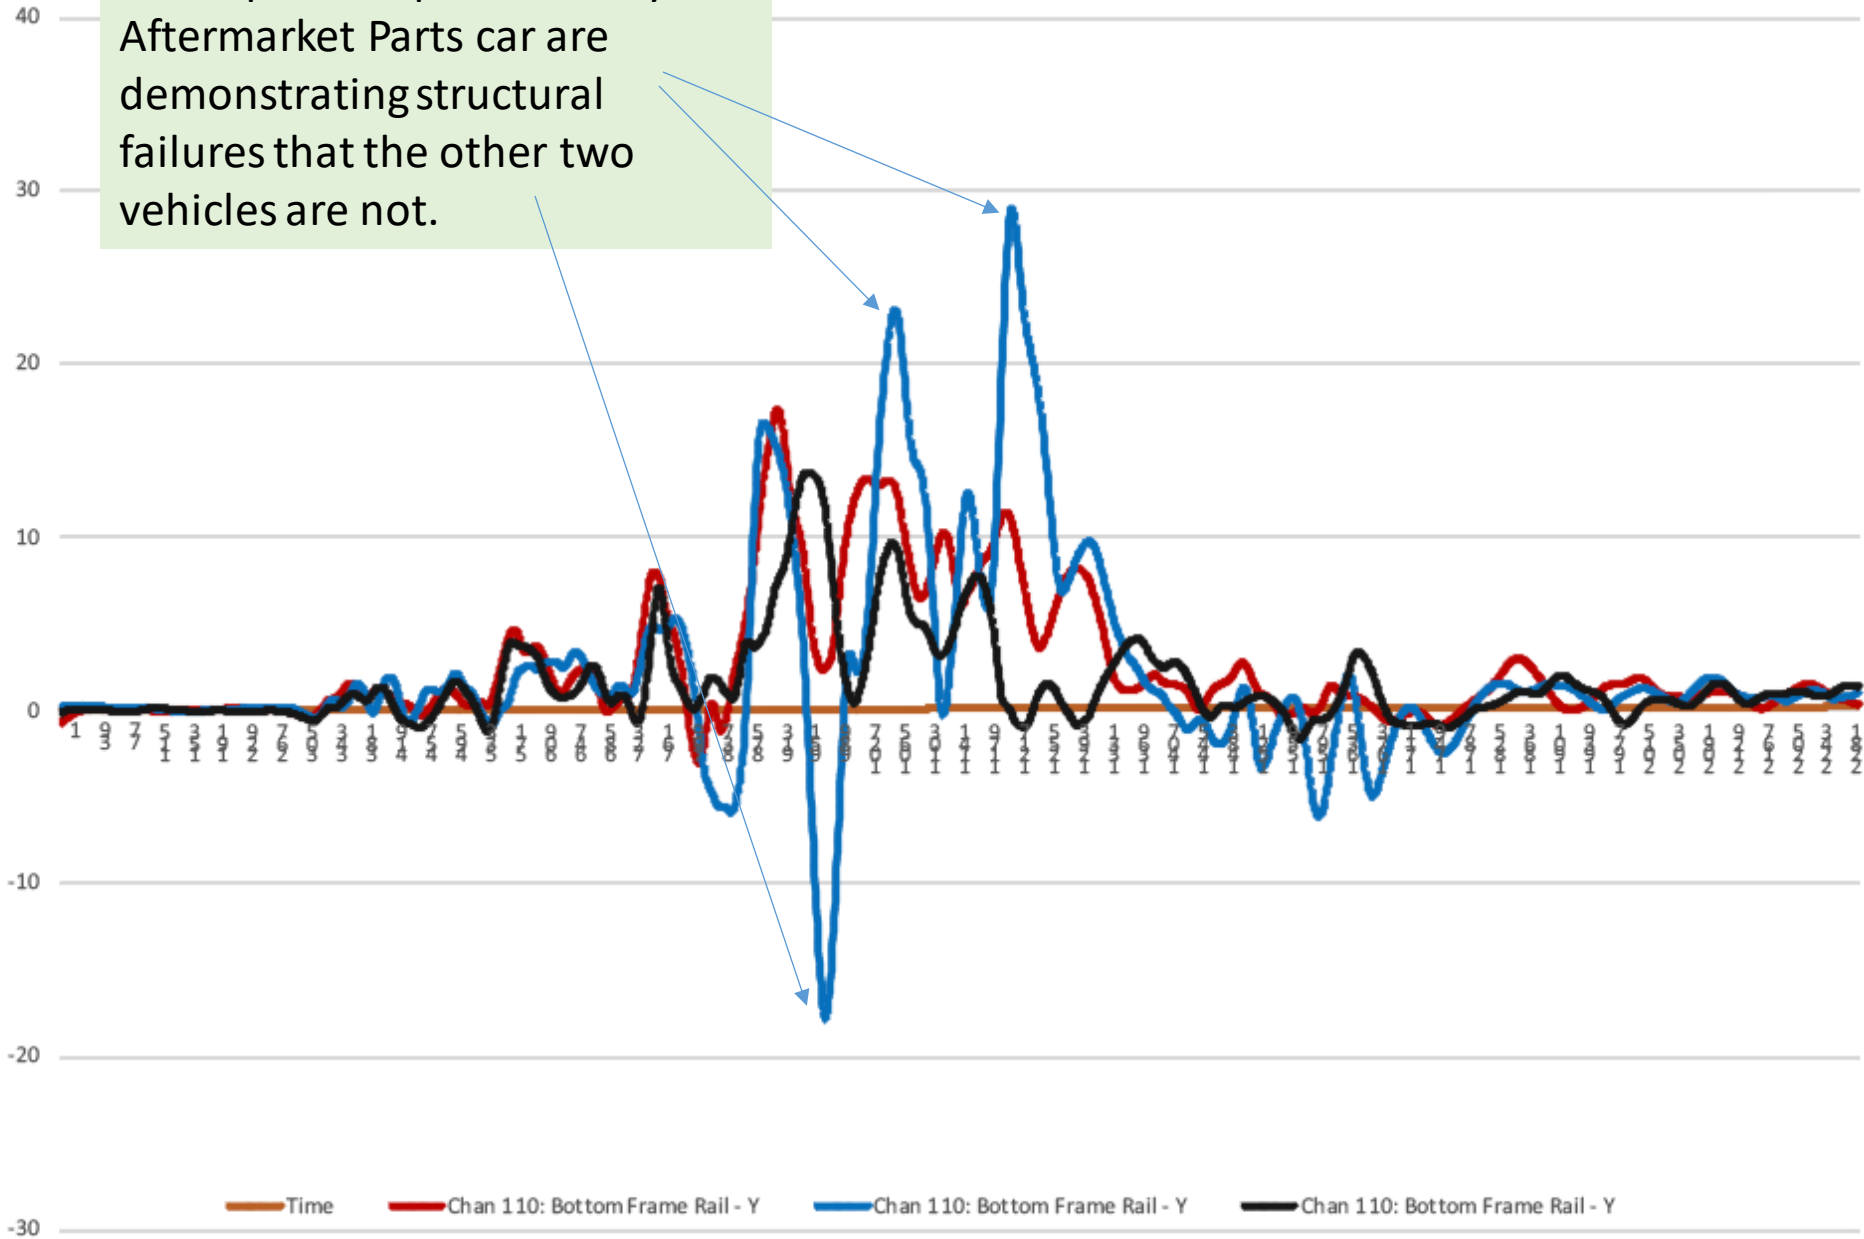
Bottom Frame Rail Sensor - Y

These peaks experienced by the Aftermarket Parts car are demonstrating structural failures that the other two vehicles are not.

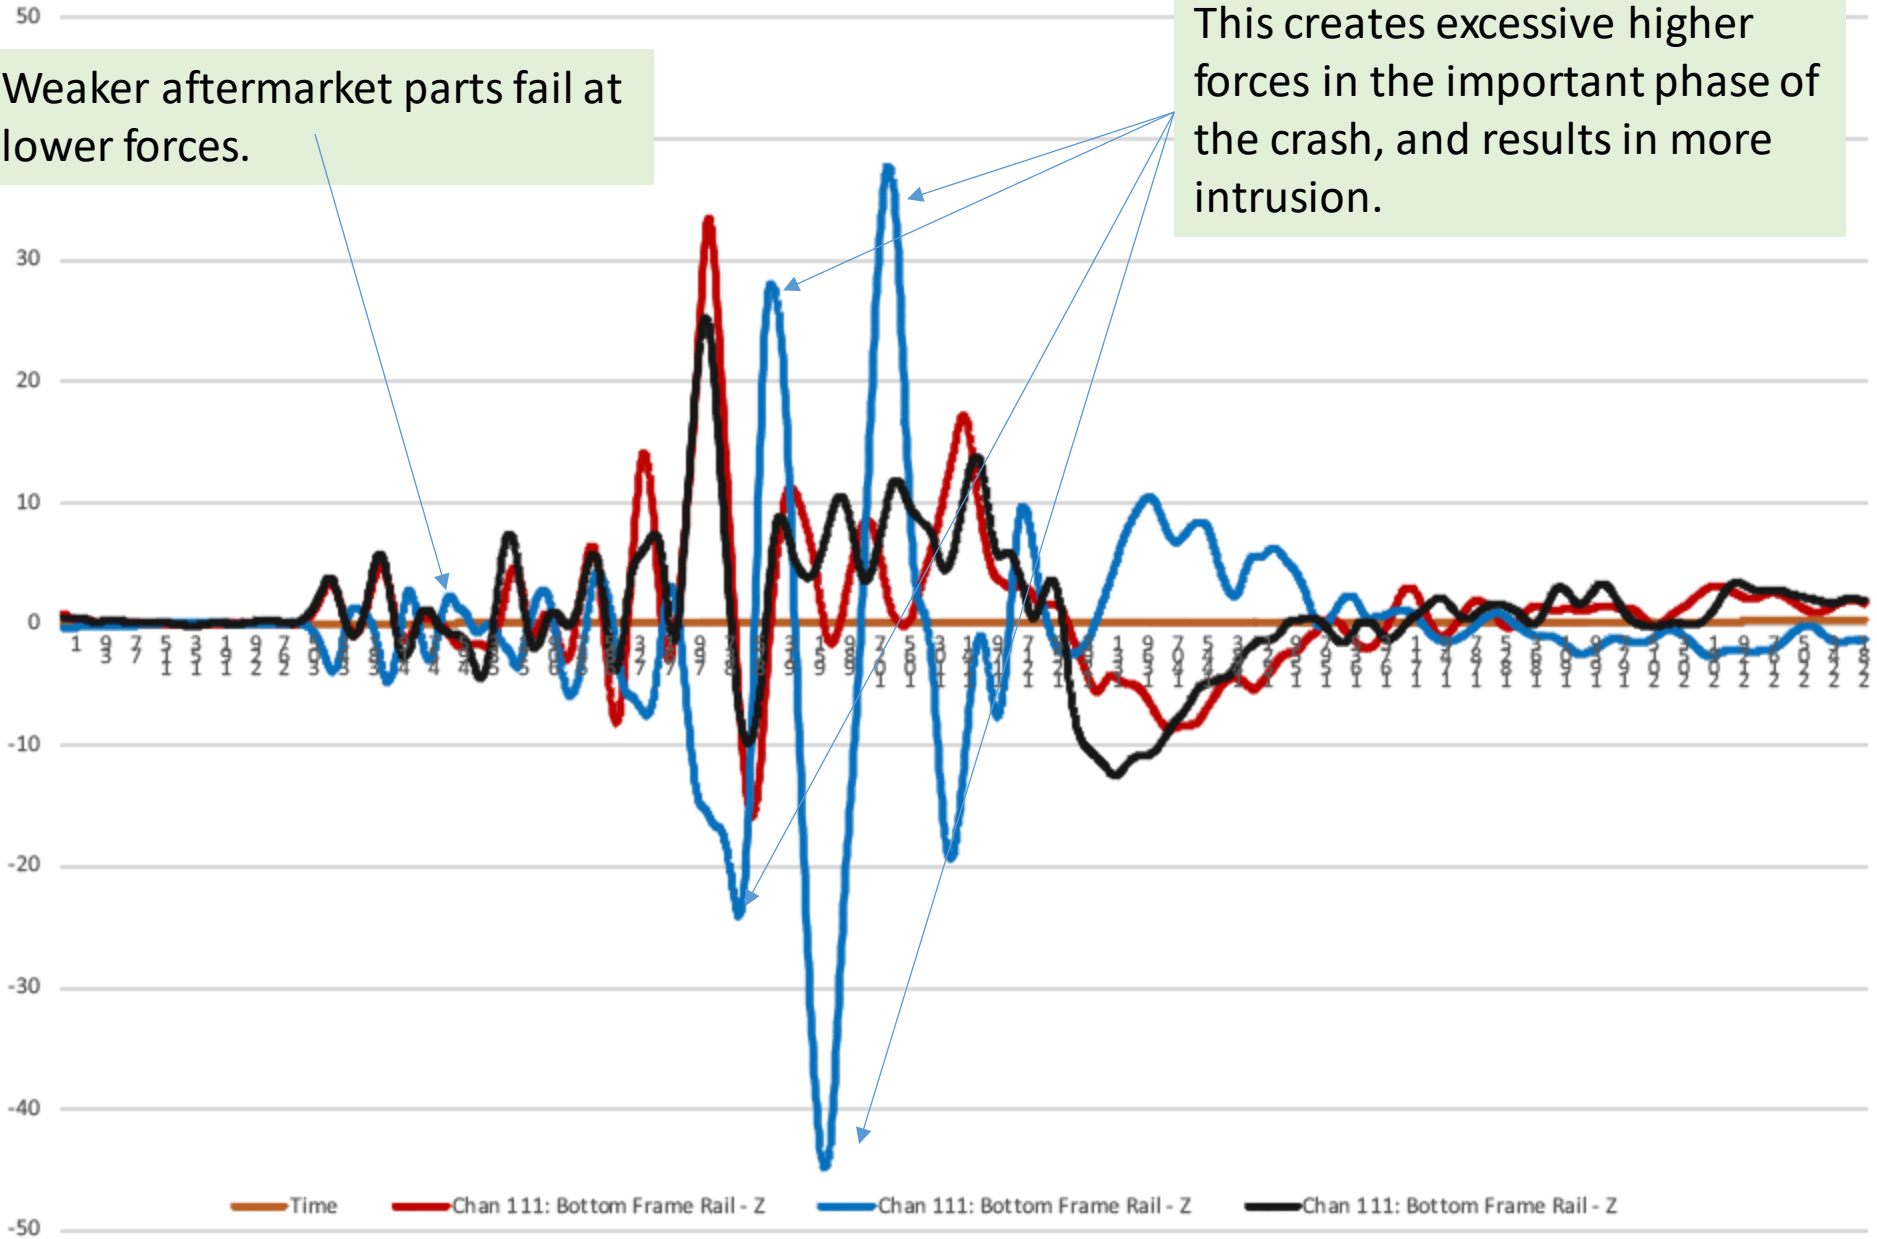
Bottom Frame Rail Sensor - Z

Weaker aftermarket parts fail at lower forces.

This creates excessive higher forces in the important phase of the crash, and results in more intrusion.

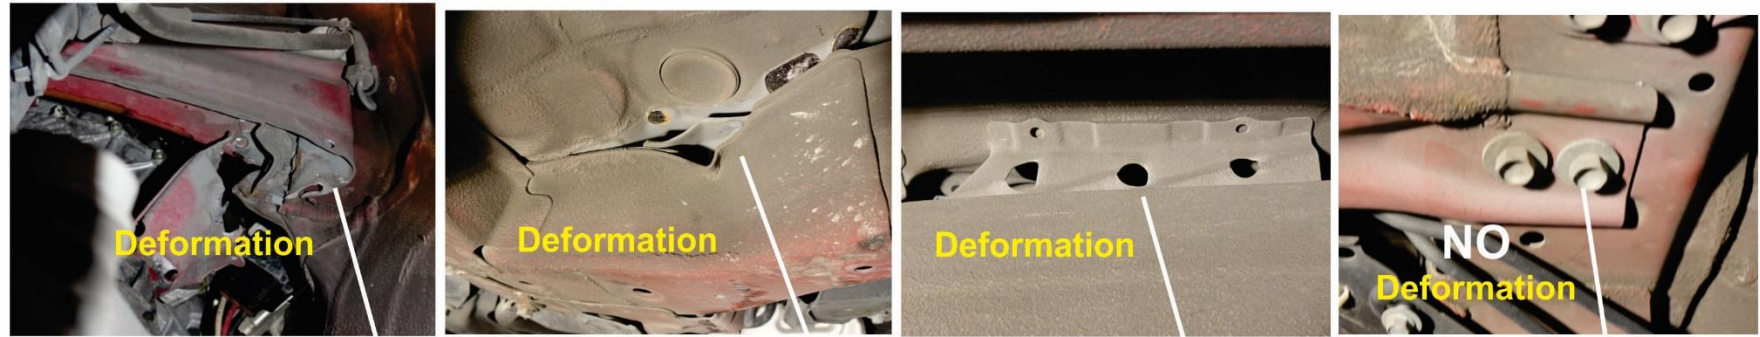
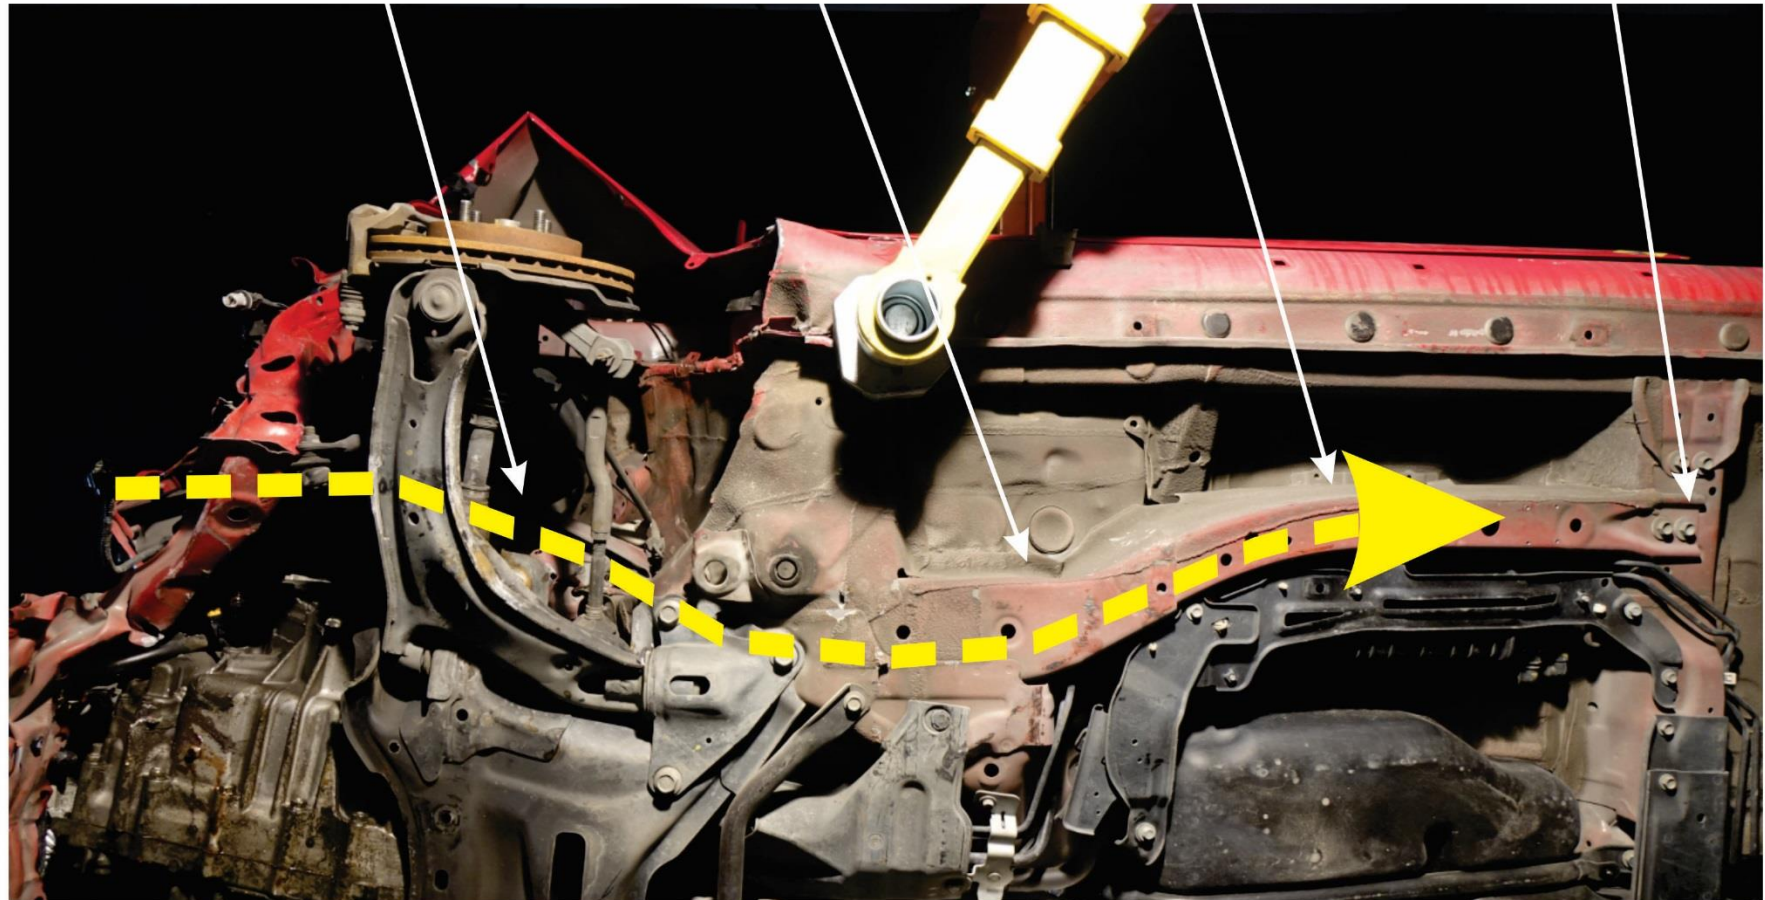
Roof Adhesive

Frame buckled underneath the driver

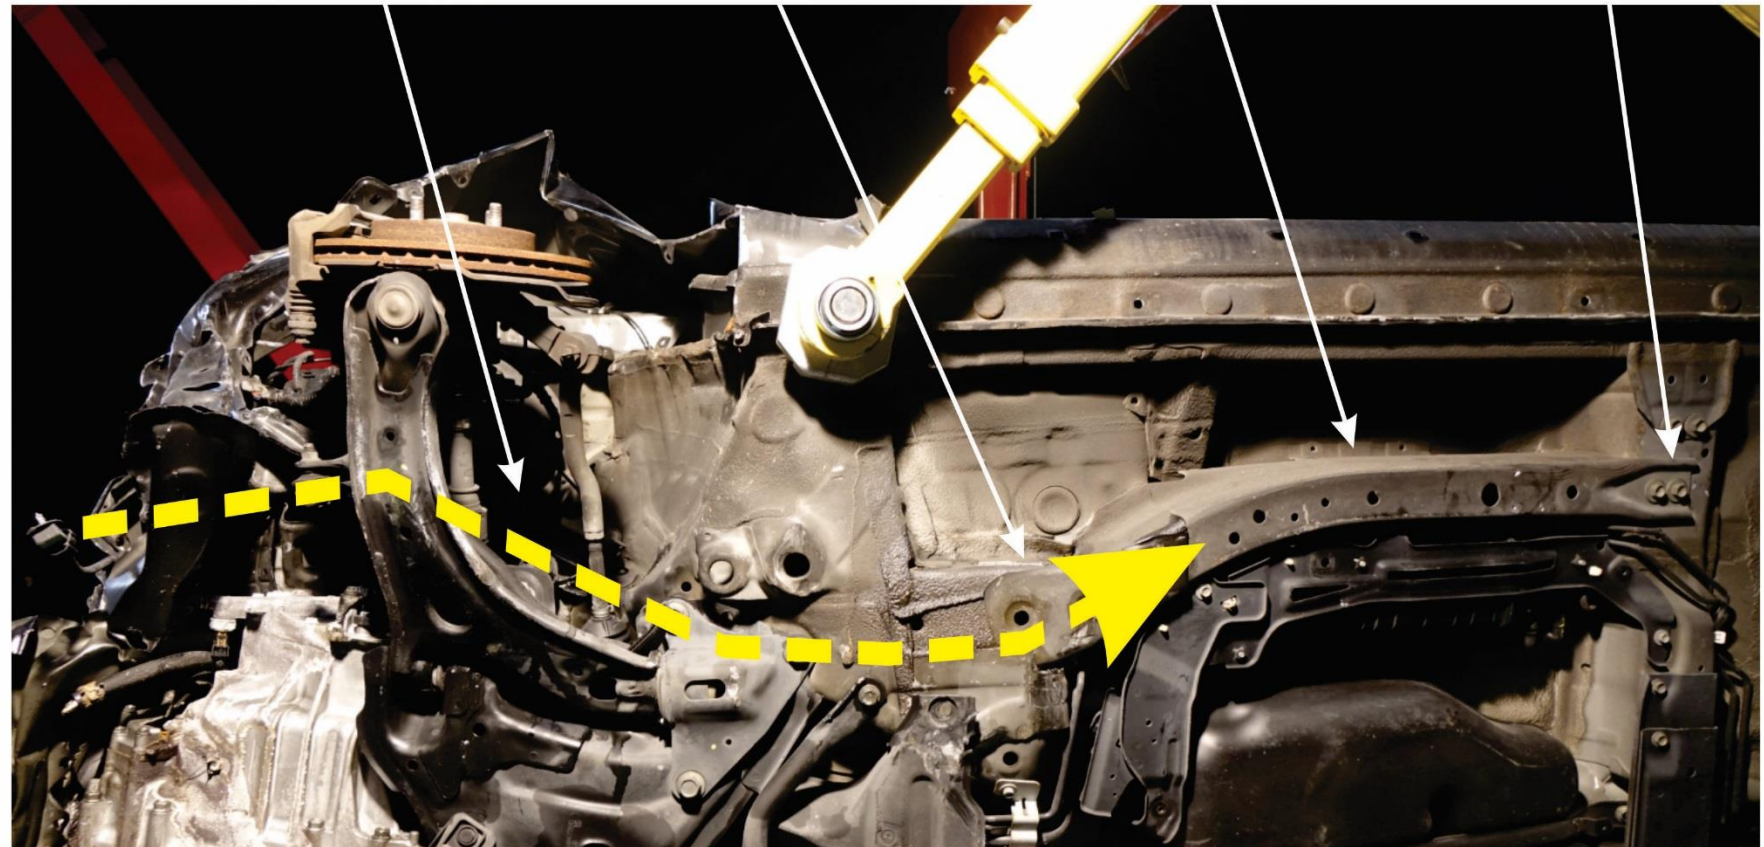
Honda OEM

No frame damage underneath the driver

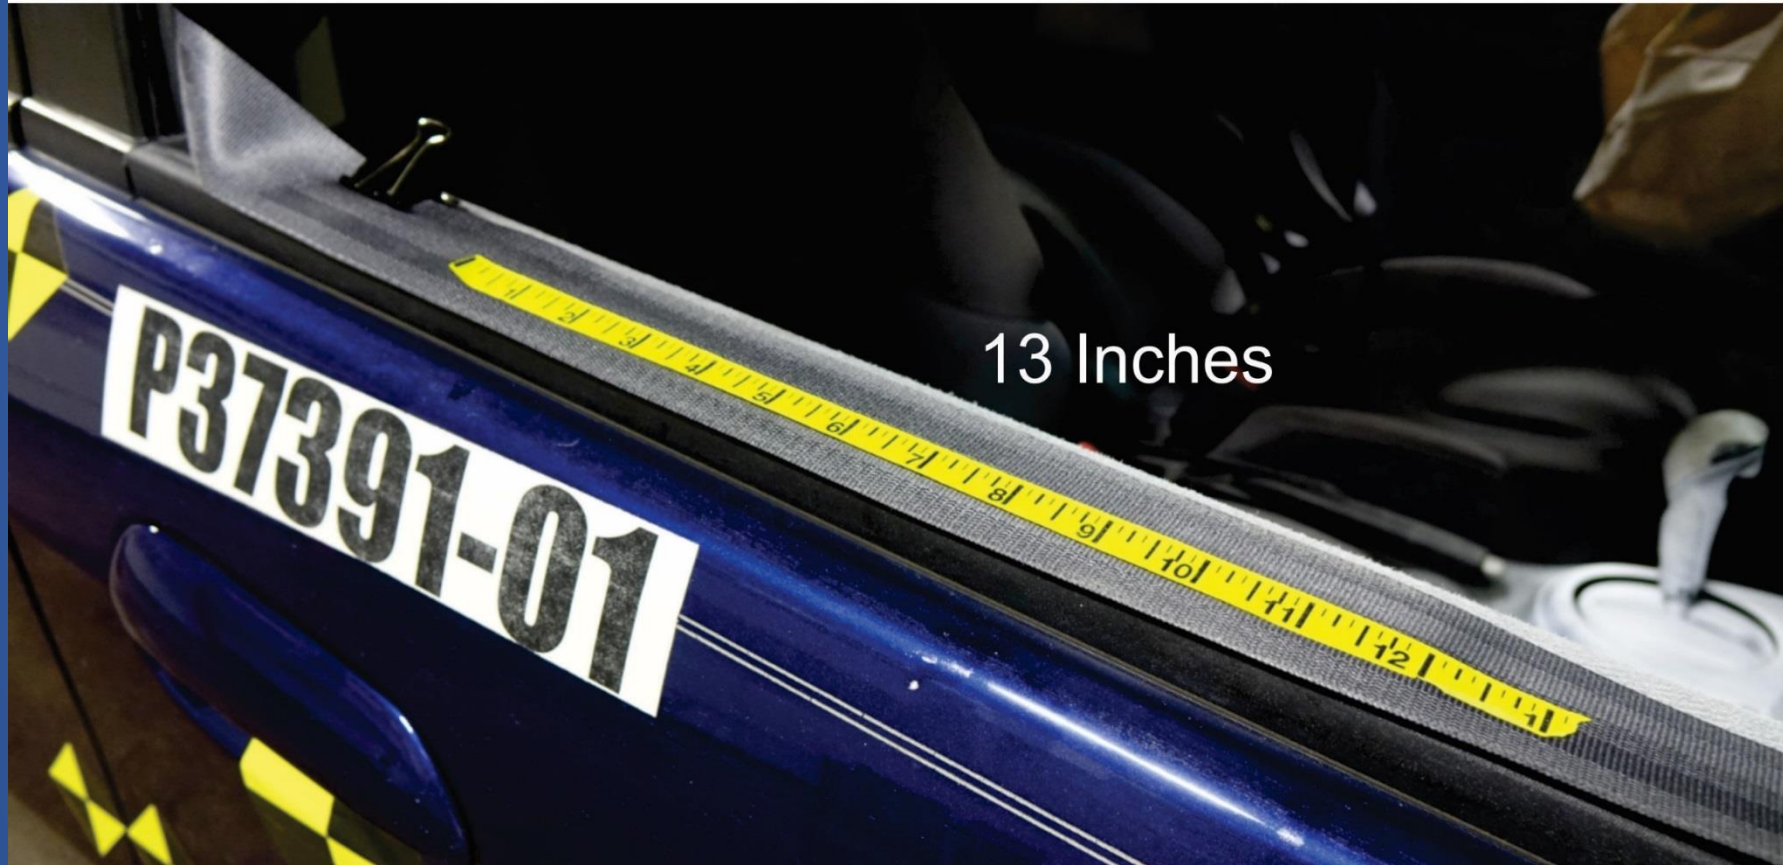
Aftermarket Parts

Excessive Frame Crush Affects Seatbelt Performance

13 Inches

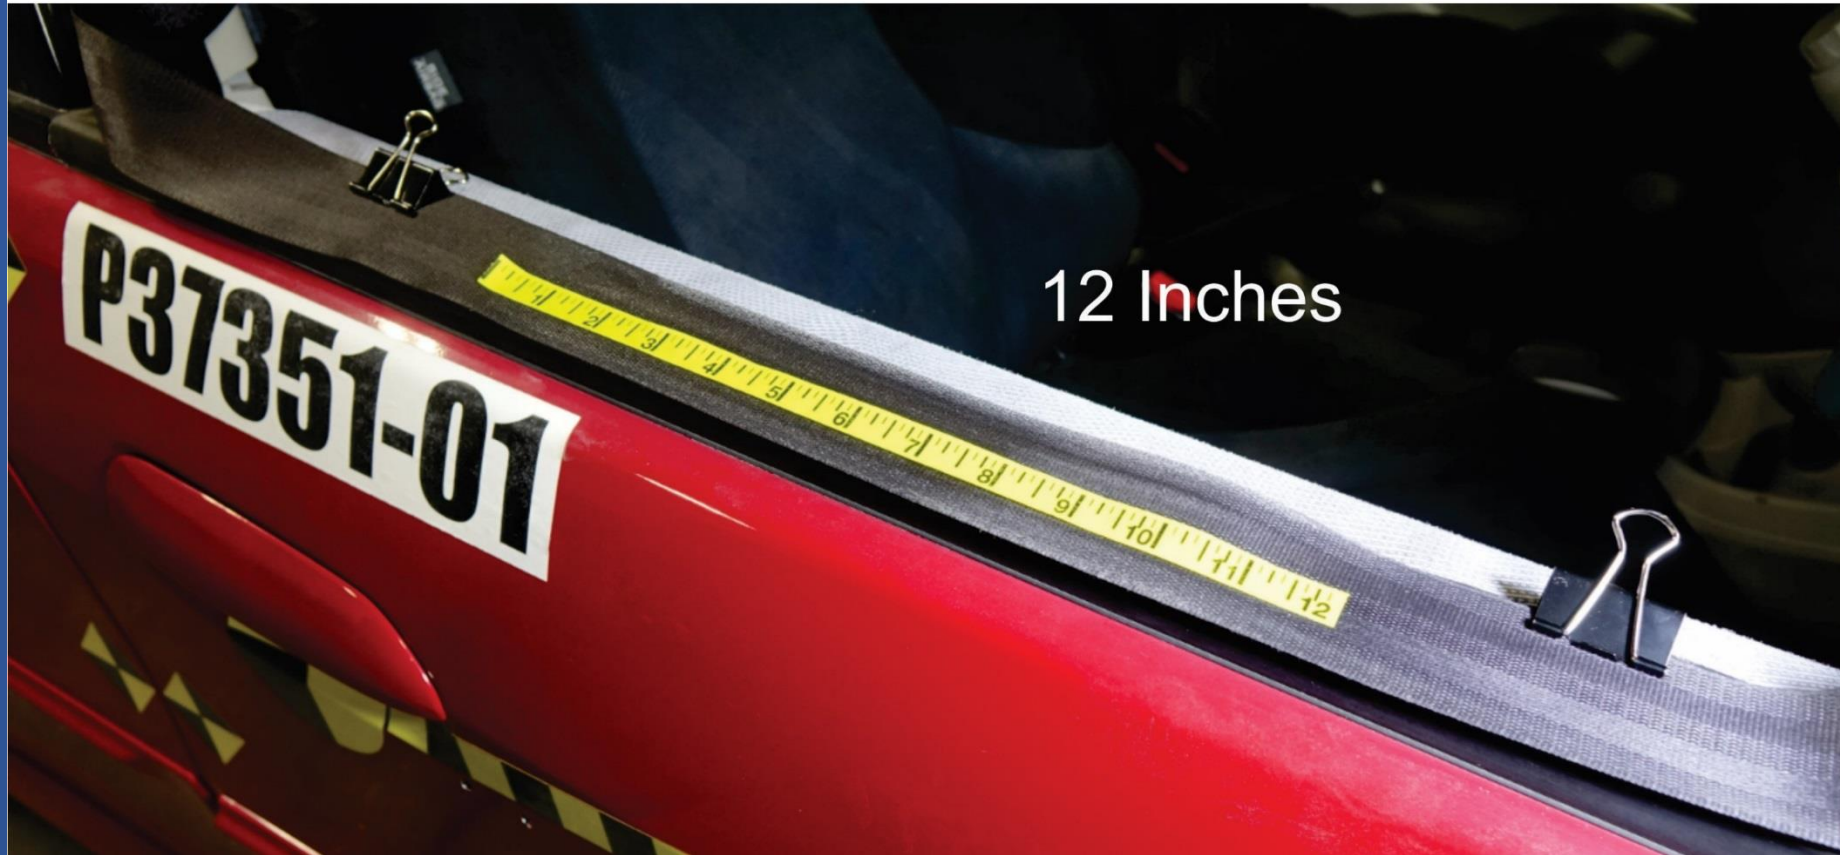
Roof Adhesive

Excessive Frame Crush Affects Seatbelt Performance

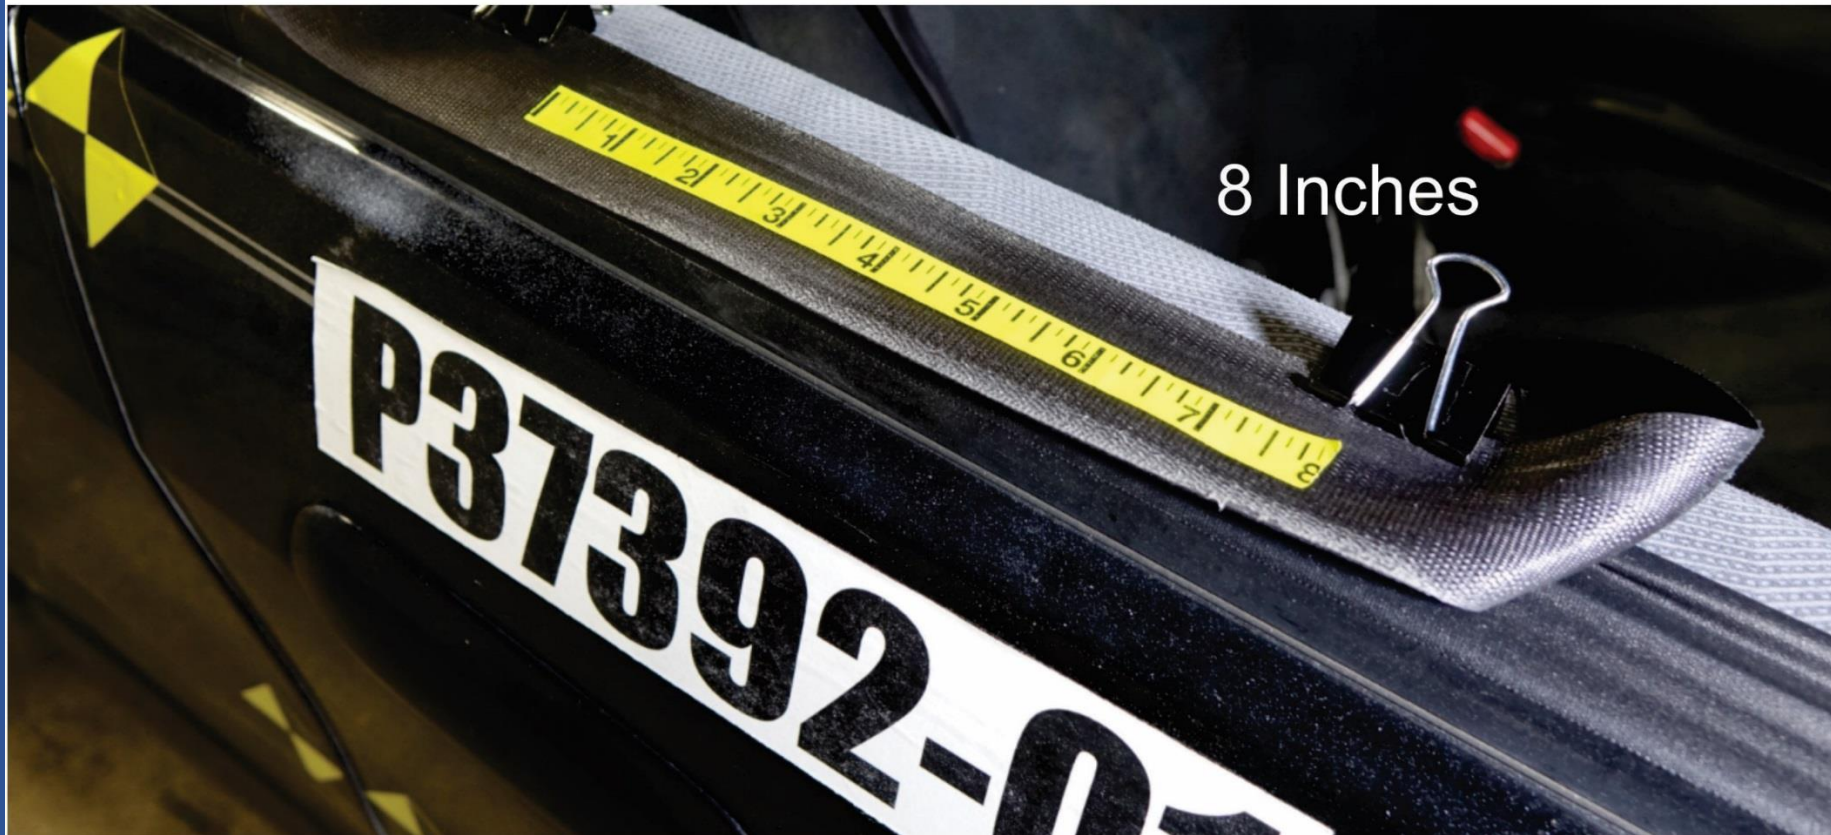
Honda OEM

When Safety Systems Work Together, The Seatbelt System Works More Efficiently

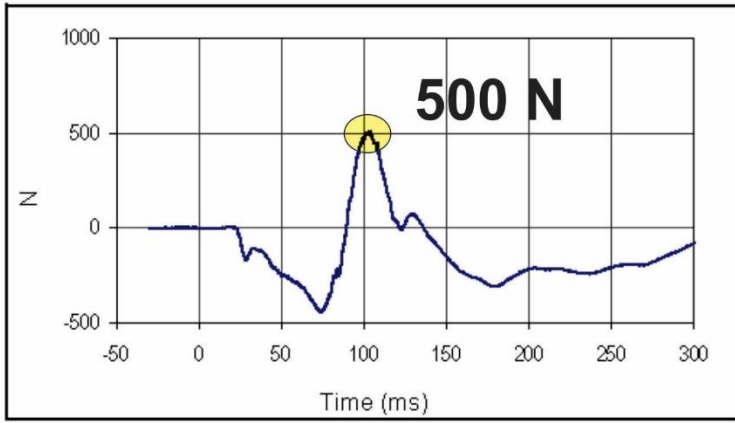
Roof Adhesive

Inadequate Repairs and Material Cause Neck Injury

Curve Description			
Driver Upper Neck Force X			
Plot No.		SAE Class	Units
009		1000	N
Max	Time	Min	Time
508.6	104.2	-444.0	74.3

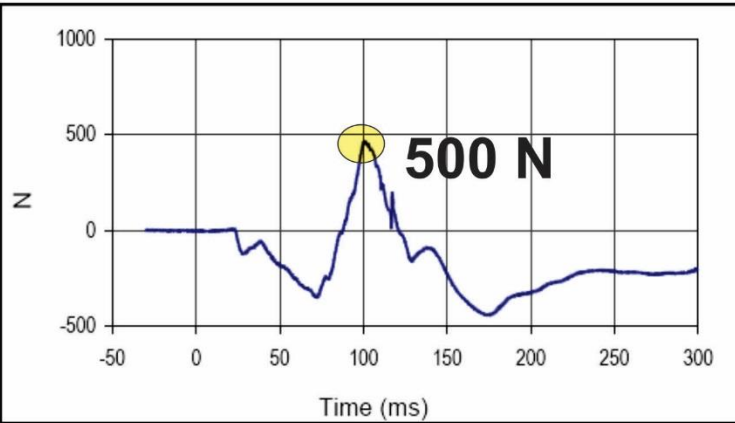
Aftermarket Parts

Curve Description			
Driver Upper Neck Force X			
Plot No.		SAE Class	Units
009		1000	N
Max	Time	Min	Time
465.7	101.4	-439.9	175.3

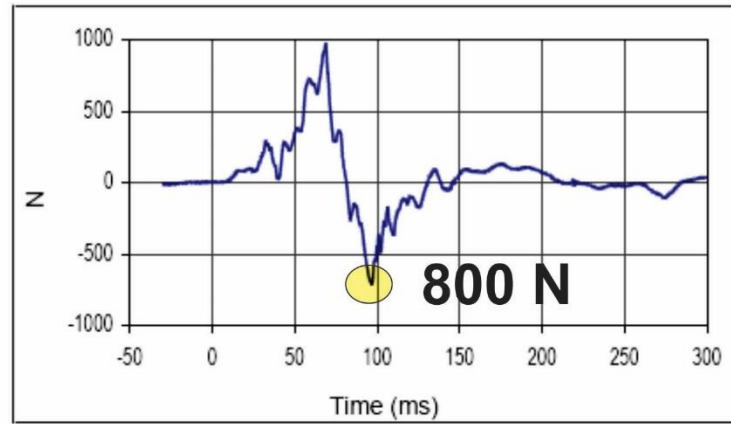
Roof Adhesive

Inadequate Repairs and Material Cause Femur Fractures

Curve Description			
Driver Left Femur Force Z			
Plot No.	SAE Class	Units	
033	600	N	
Max	Time	Min	Time
971.1	68.8	-708.9	96.6

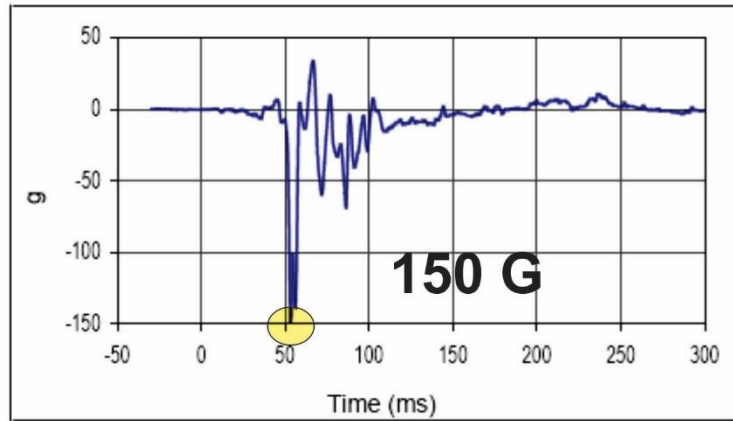
Roof Adhesive

Inadequate Repairs and Material Cause Ankle Fractures

Curve Description			
Driver Right Toe Acceleration Z			
Plot No.		SAE Class	Units
056		180	g
Max	Time	Min	Time
33.9	66.6	-149.3	53.3
