Put Your Money Where Your Mouth is

**So That's Exactly
What Was Done**

**Todd Tracy
Dallas, Texas**

**IIHS
Moderate
Overlap Test
Protocol
Followed to
the Letter**

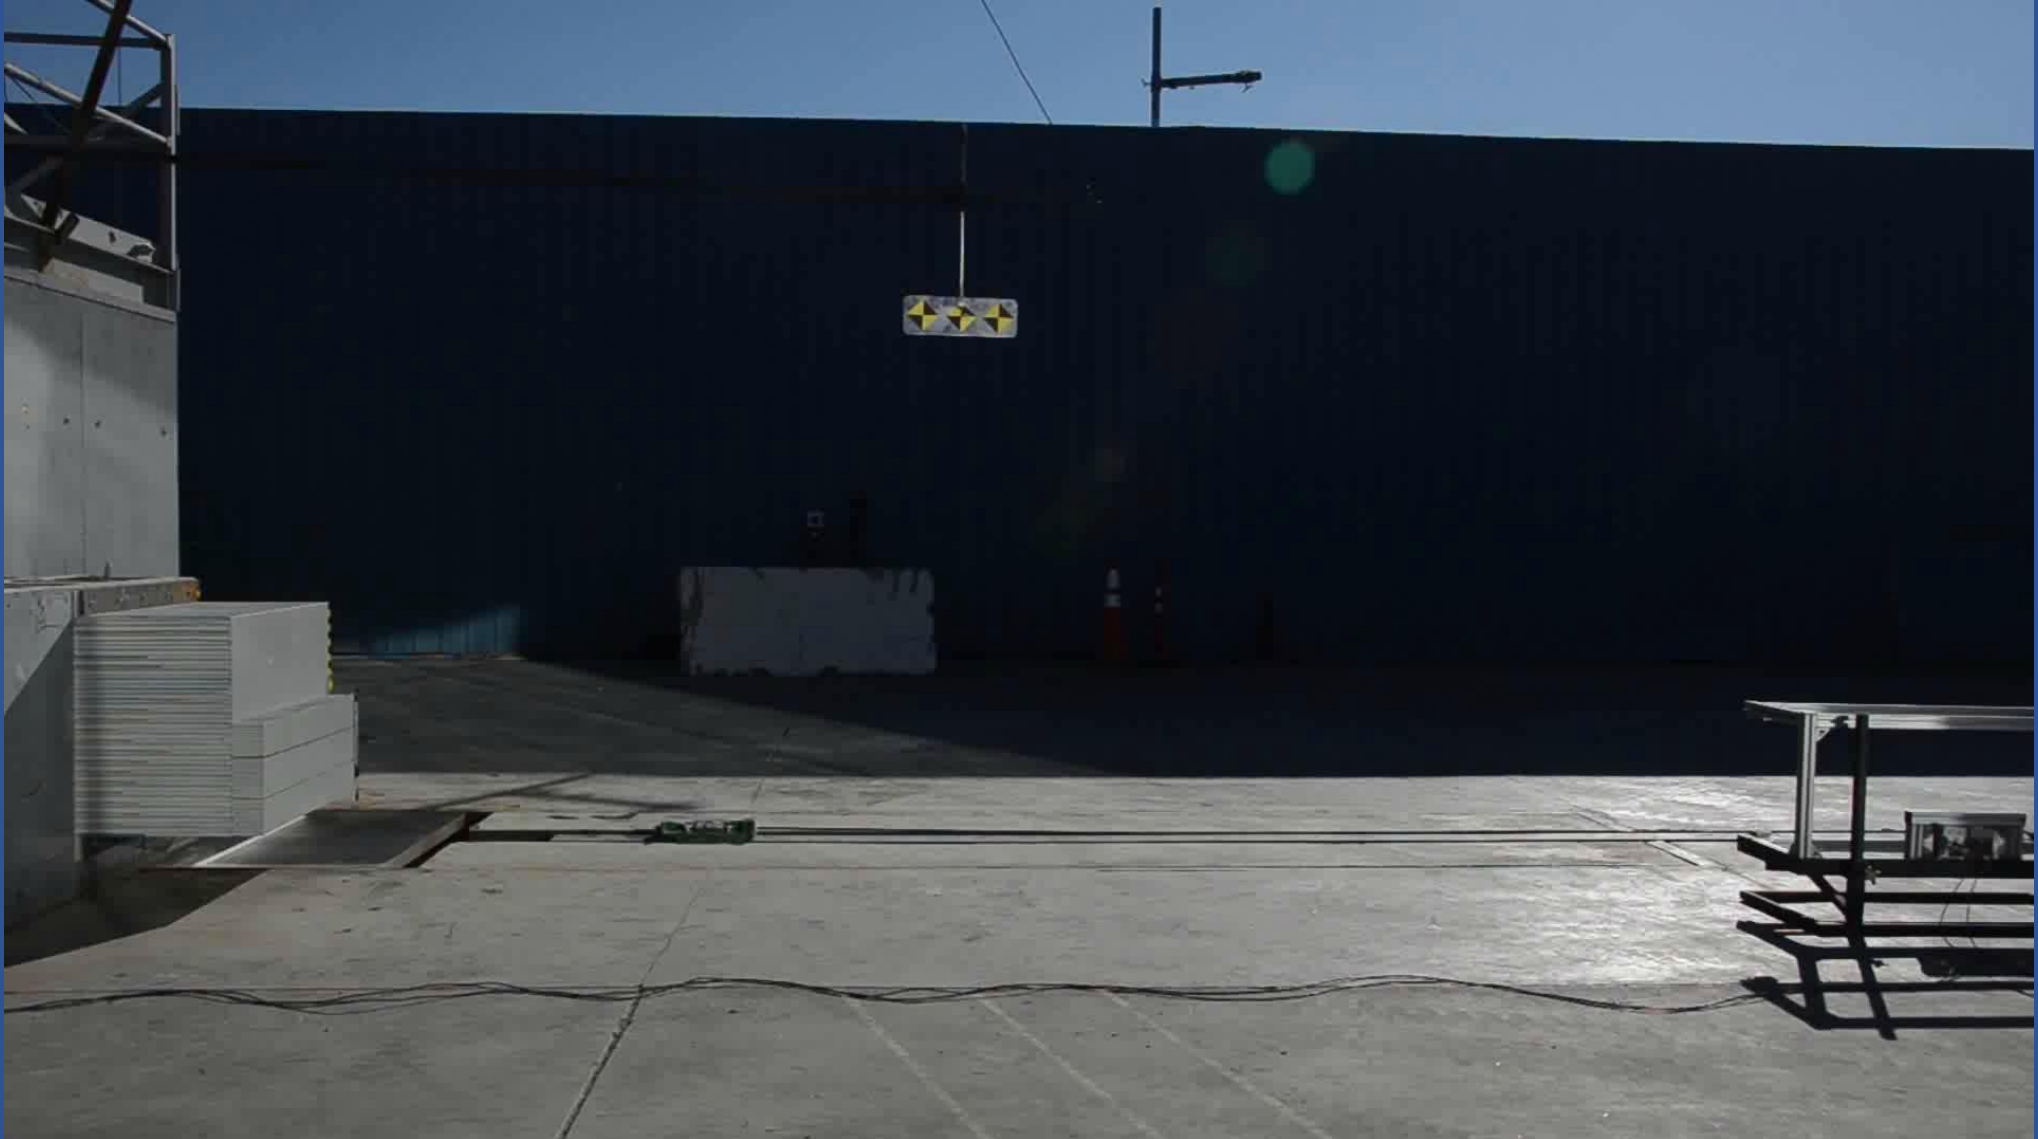
Test #2 (Blue Test)

Roof Removed and Reapplied with Adhesive

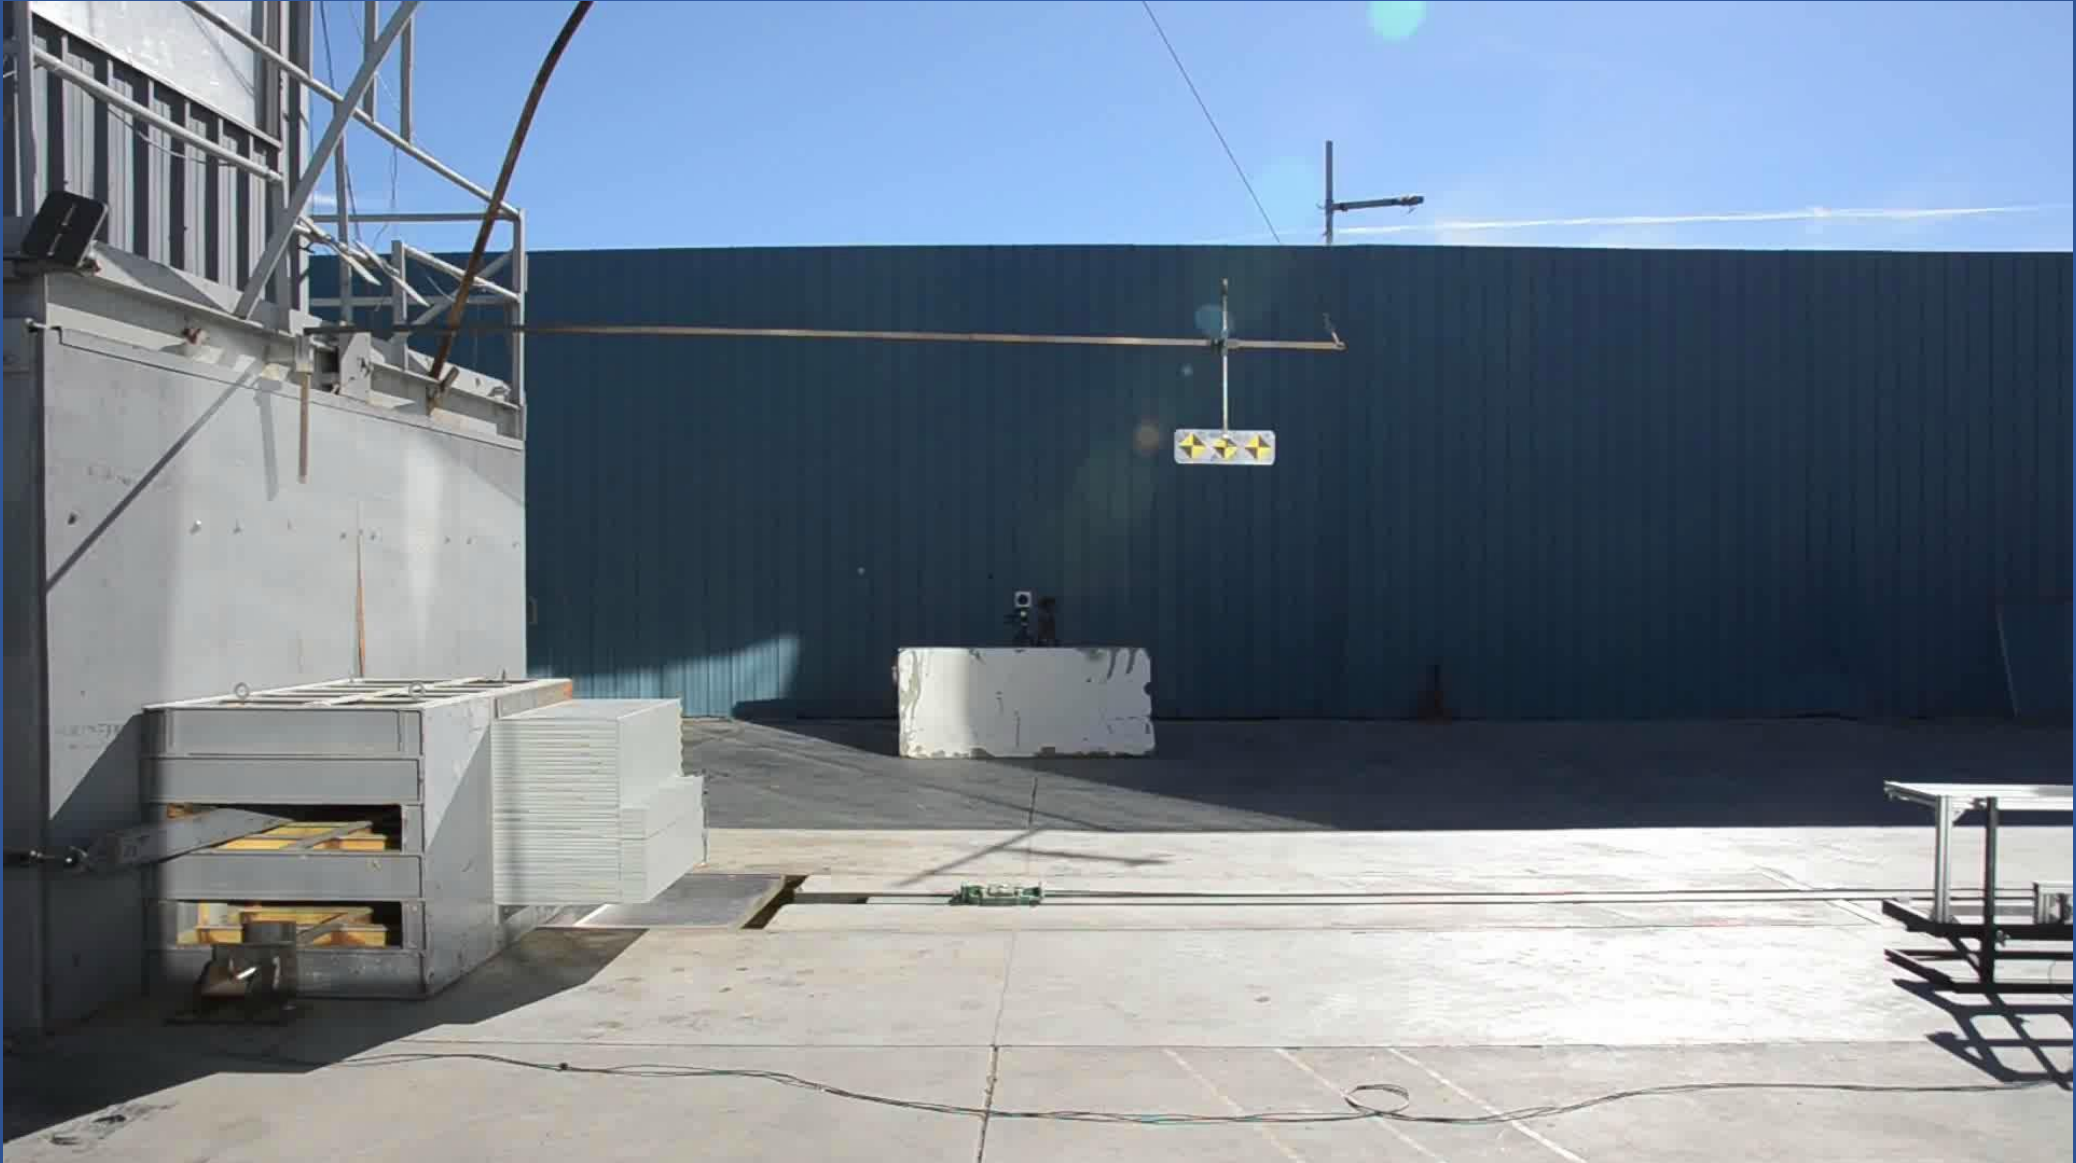
Test #1 (Red Test)

No Modifications from Original Factory Condition

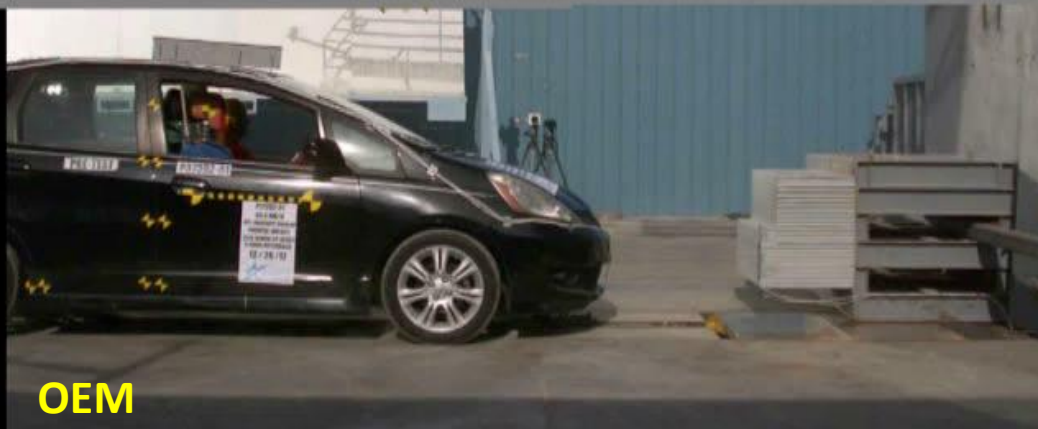
OEM

Excessive Frame Crush Affects Seatbelt Performance

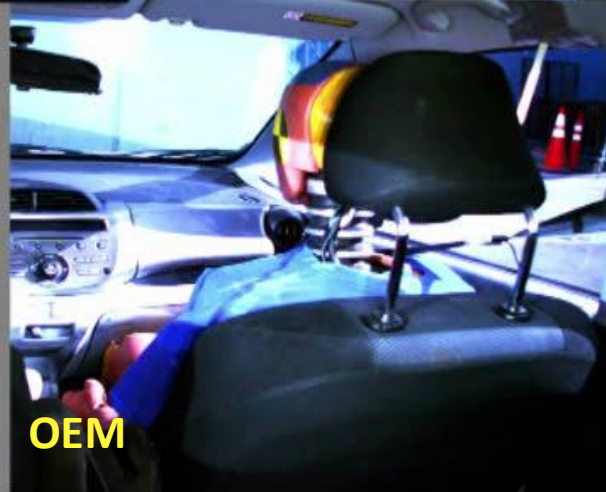
OEM

Excessive Structural Crush and Increased Seatbelt Payout Negatively Affects Seatbelt Performance

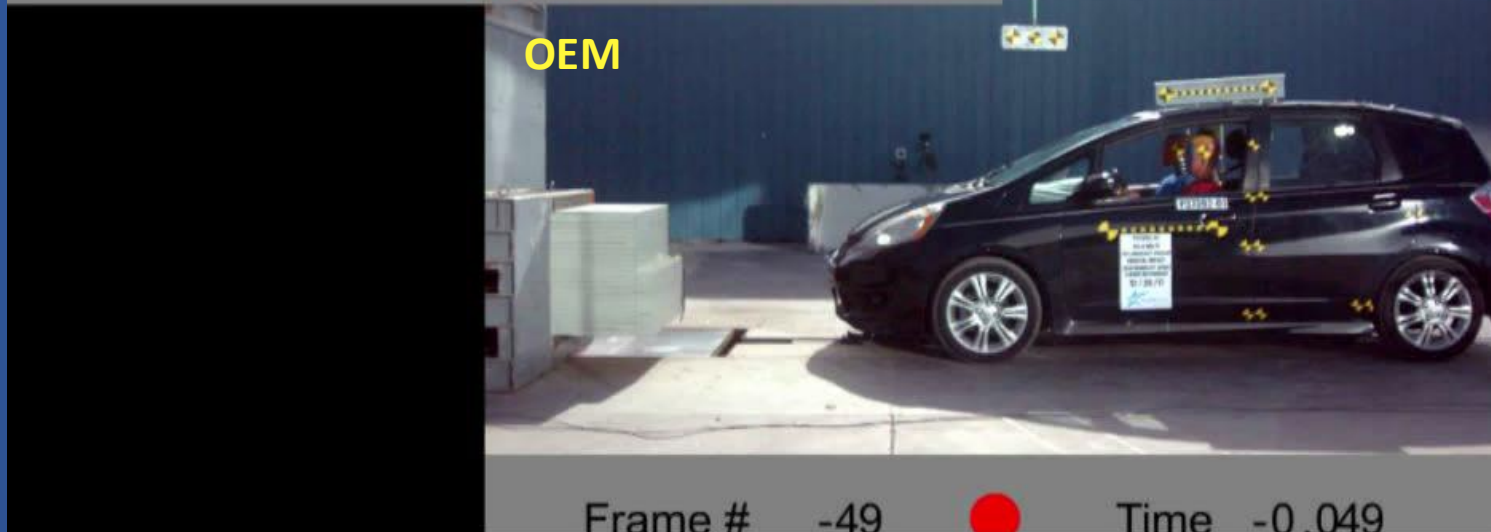
The HIC numbers for the adhesive vehicle are high because the vehicle failed to properly distribute energy

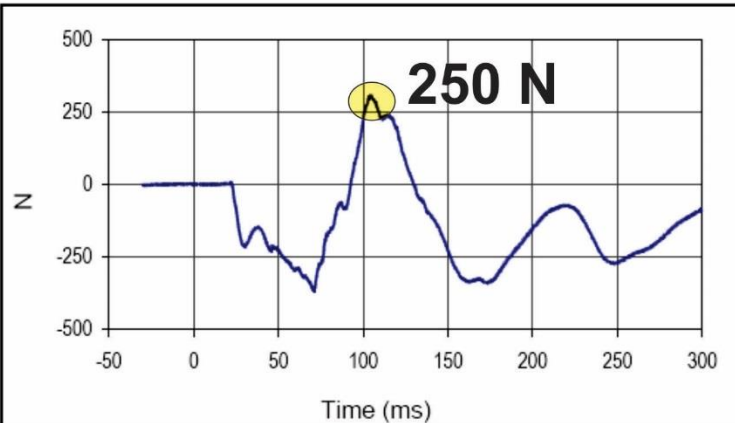
Honda OEM

Inadequate Repairs and Material Cause Neck Injury

Curve Description			
Driver Upper Neck Force X			
Plot No.		SAE Class	Units
009		1000	N
Max	Time	Min	Time
306.5	104.4	-370.5	71.1

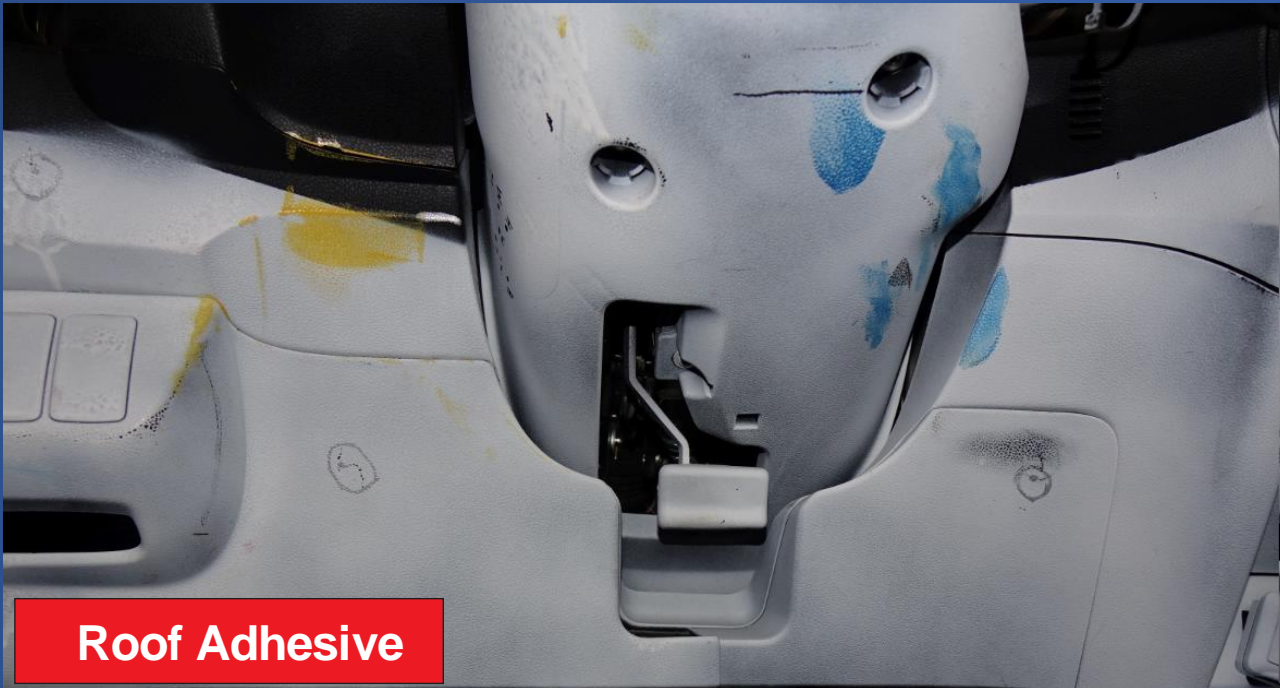
Roof Adhesive

Inadequate Repairs and Material Cause Femur Fractures

Curve Description			
Driver Left Femur Force Z			
Plot No.	SAE Class	Units	
033	600	N	
Max	Time	Min	Time
971.1	68.8	-708.9	96.6

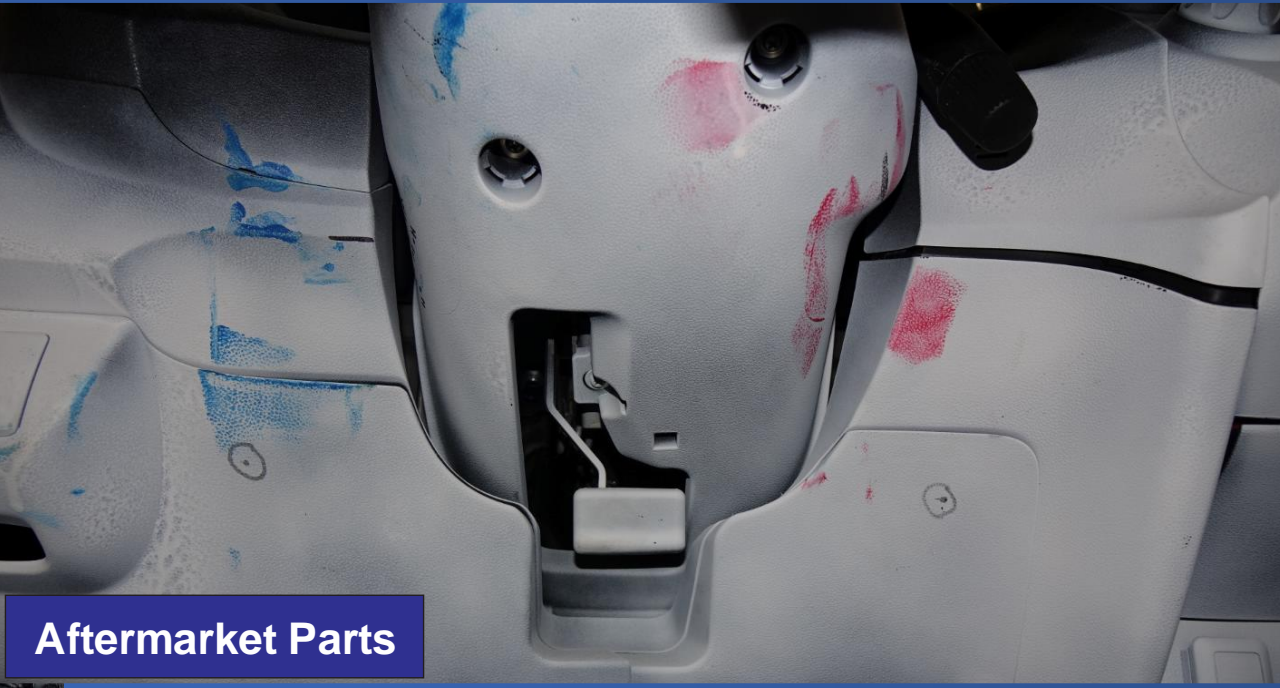
Aftermarket Parts

Curve Description			
Driver Left Femur Force Z			
Plot No.	SAE Class	Units	
033	600	N	
Max	Time	Min	Time
1178.6	61.9	-1685.4	101.4

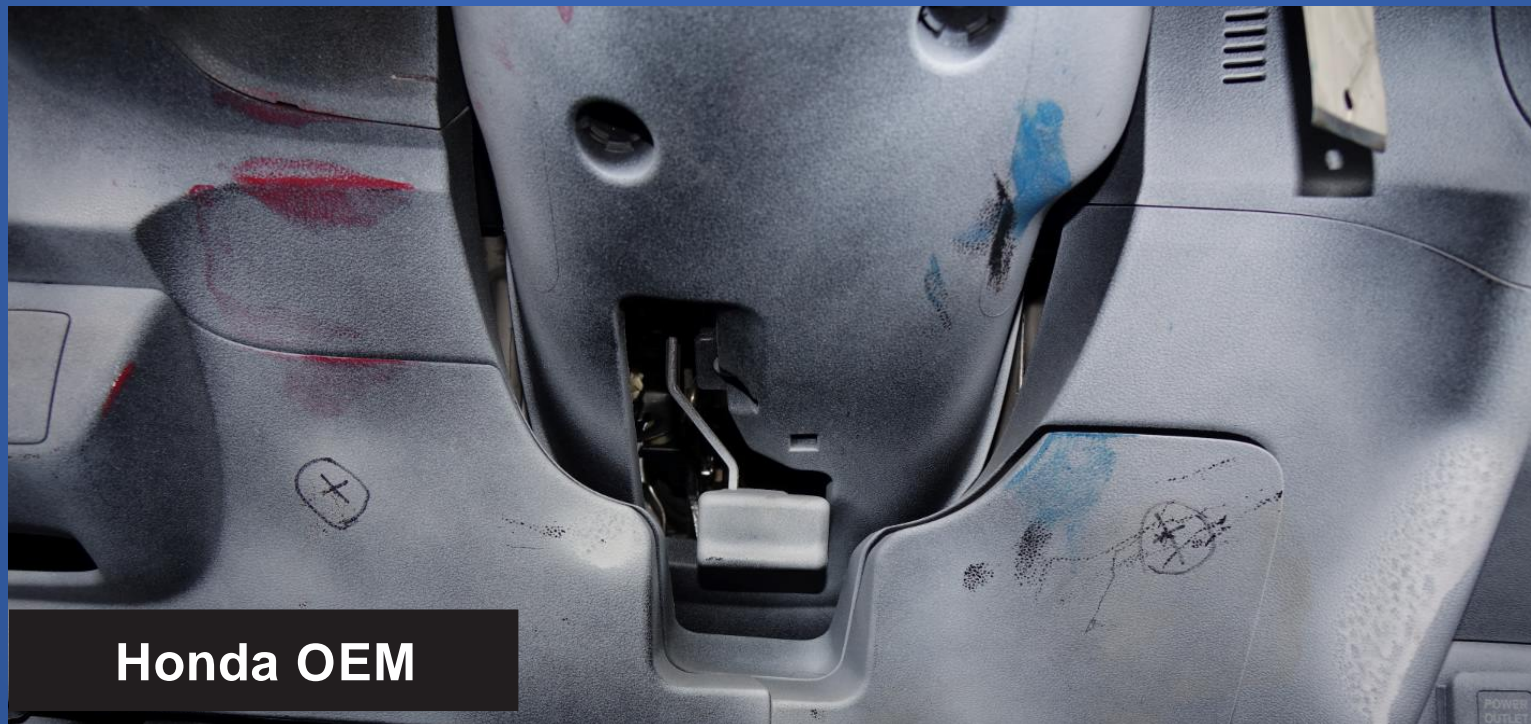
Honda OEM

Curve Description			
Driver Left Femur Force Z			
Plot No.	SAE Class	Units	
033	600	N	
Max	Time	Min	Time
960.8	78.8	-179.7	117.1

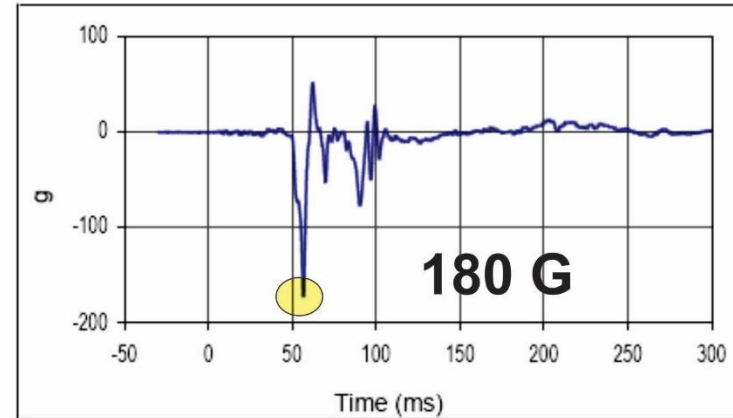
Inadequate Repairs and Material Cause Ankle Fractures

Curve Description			
Driver Right Toe Acceleration Z			
Plot No.		SAE Class	Units
056		180	g
Max	Time	Min	Time
51.1	62.1	-173.6	56.6

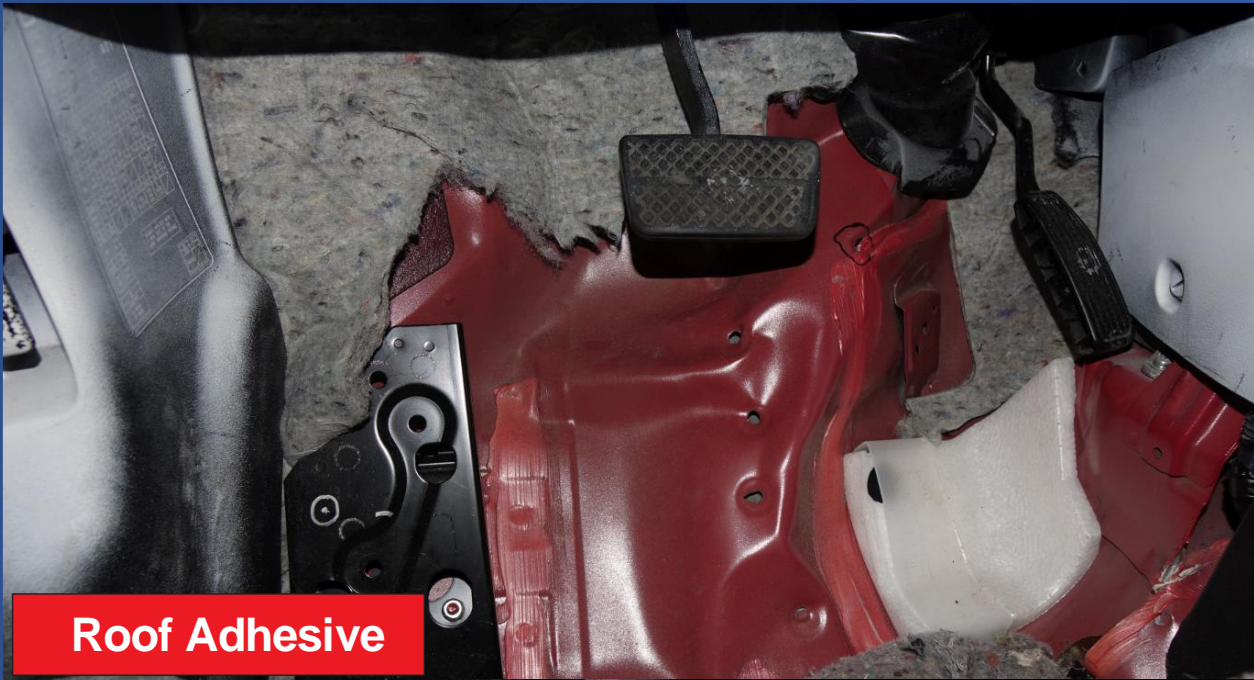
Roof Adhesive

Curve Description			
Driver Right Toe Acceleration Z			
Plot No.		SAE Class	Units
056		180	g
Max	Time	Min	Time
33.9	66.6	-149.3	53.3

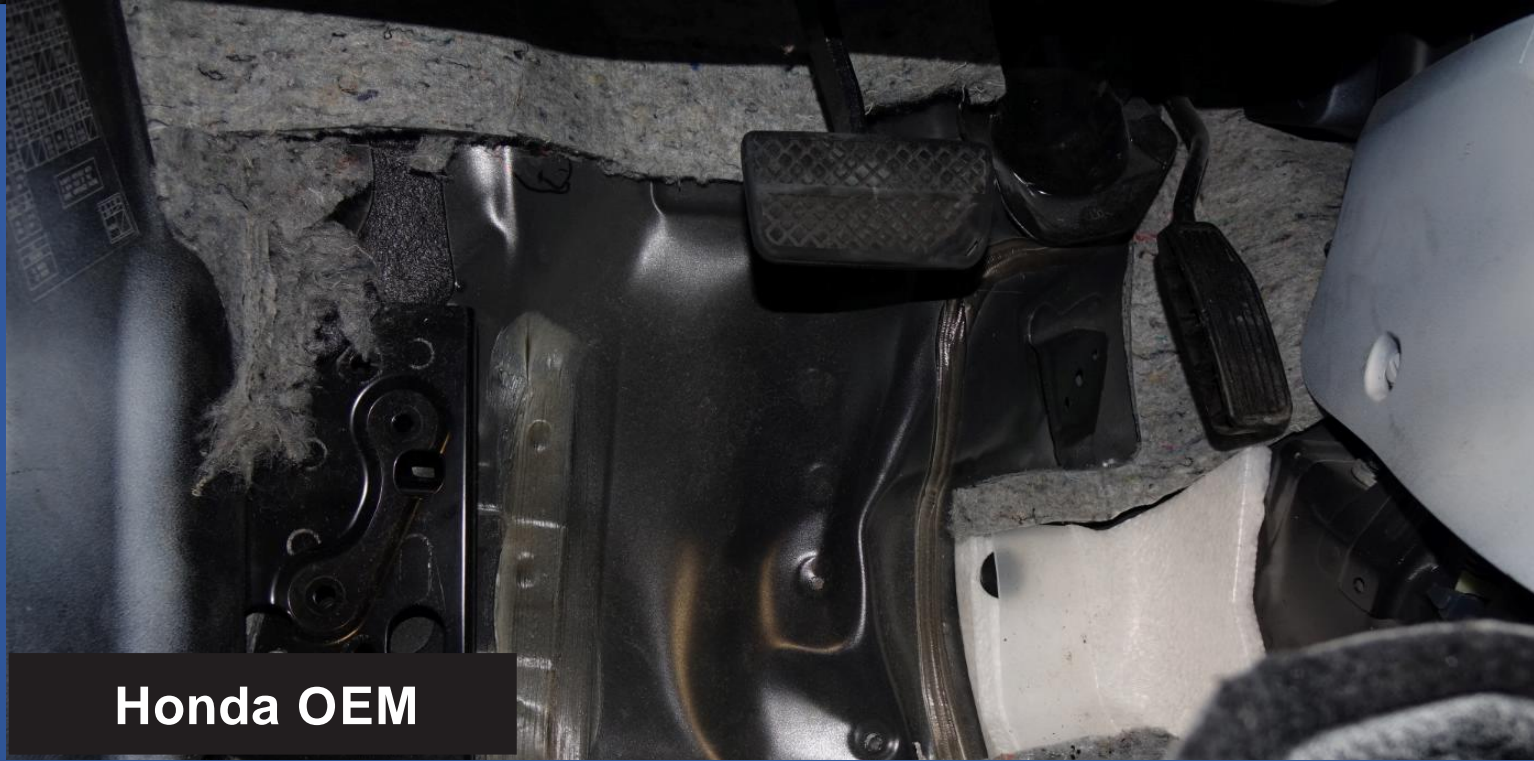
Honda OEM

Curve Description			
Driver Right Toe Acceleration Z			
Plot No.		SAE Class	Units
056		180	g
Max	Time	Min	Time
18.2	203.7	-102.1	89.3
